On-scene Investigation / Vehicle to Vehicle  
Dynamic Science, Inc. / Case Number: DS9520  
1985 GMC school bus  
Arizona  
, 1995

1. Report No. <b>DS9520</b>		2. Government Accession No.		3. Recipient Catalog No.	
4. Title and Subtitle <b>In-Depth Accident Investigation</b>				5. Report Date 1995

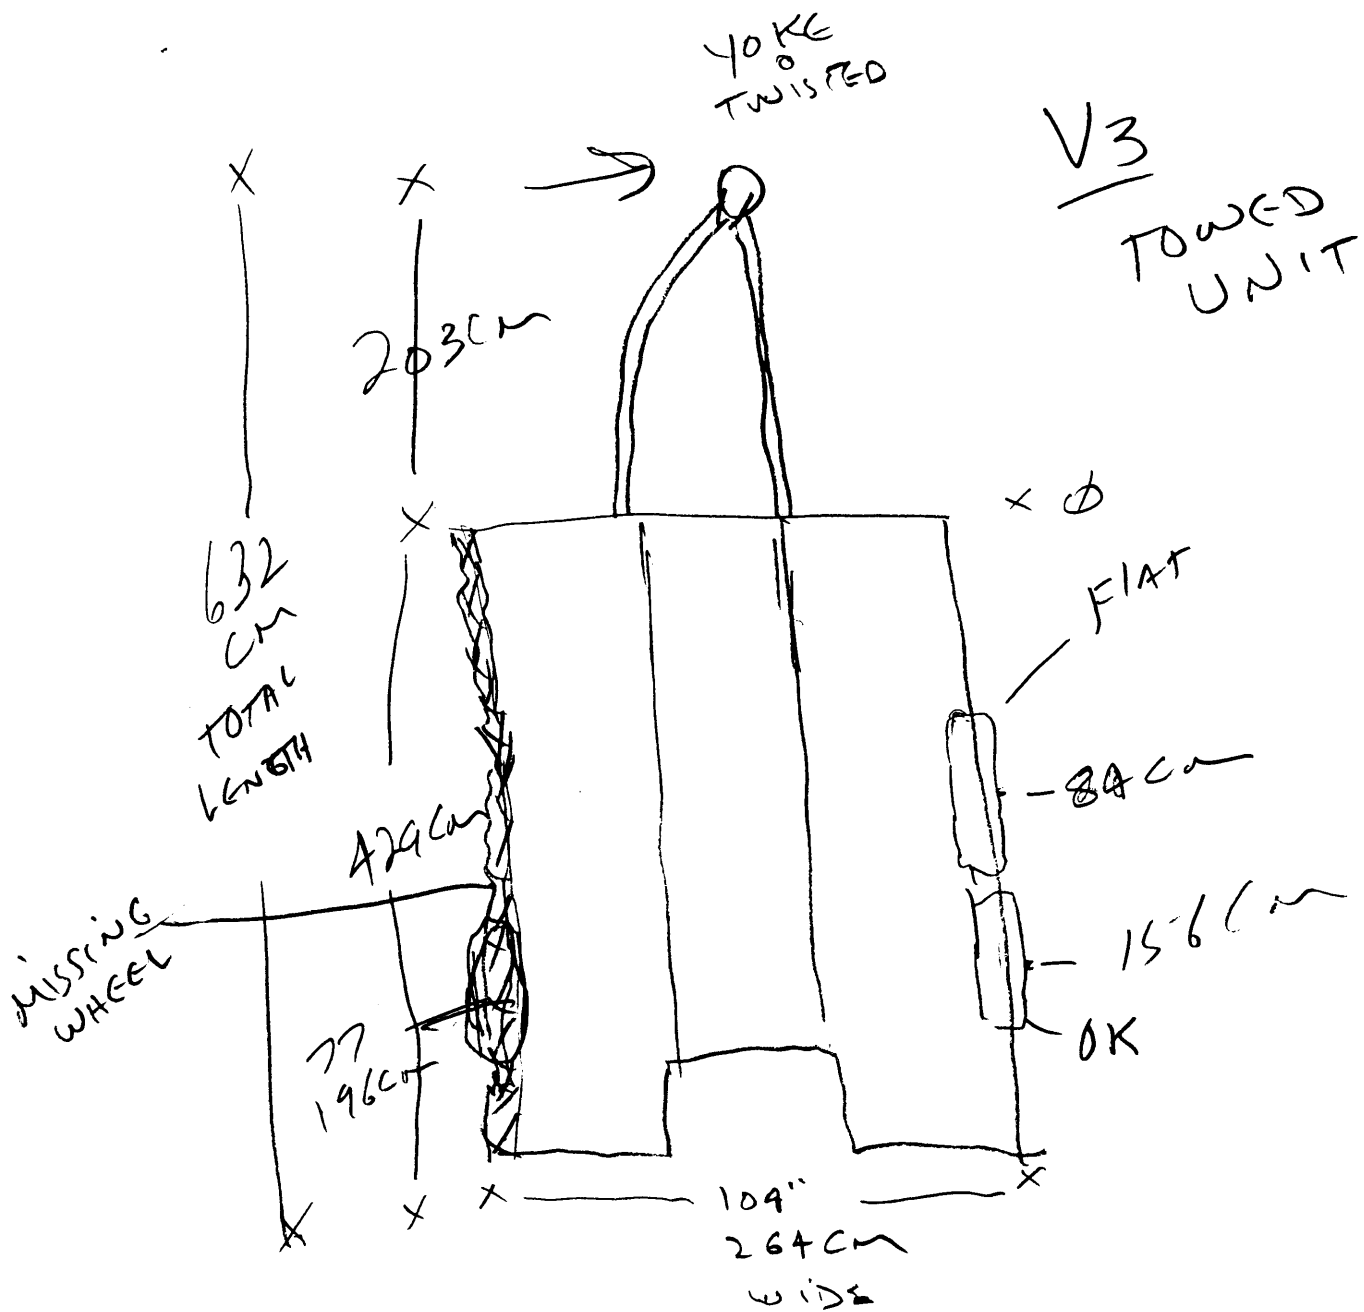
BROKEN AXLE

DAMAGE TO LEFT SIDE
